# FINAL REPORT

2023-0053

**MDM-1 M FOX, SP-8000**

**Toruń aerodrome (EPTO), 4 August 2023**

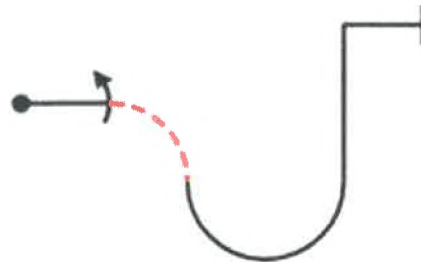
Figure 14. The first figure of the fourth programme

By lowering the wings, the pilot signalled to the judges that he was about to begin the sequence. After beginning the sequence, he was focused on correct execution of the first figure (Fig. 13), which started with a slow roll. Therefore, he no longer monitored whether the zone was free.

While executing the roll, the glider flew with its right wing in the tow line of the tow plane which was flying ahead of it in a descending turn in the northerly direction.
