State Commission on Aircraft Accidents Investigation (PKBWL)

FINAL REPORT

2022/5615

Aeroklub Zagłębia Miedziowego
Socata-Groupe Aerospaciale, Socata-Ralley 235
E-D airplane, SP-WOP
Lubin, 24 September 2022

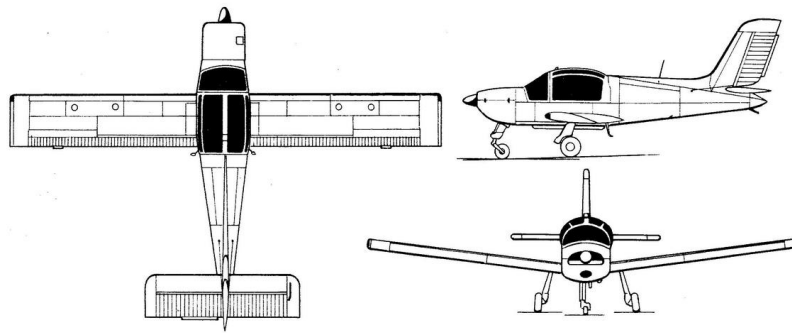
Figure 5. Socata-Rally [source: Internet]

Socata-Ralley 235 E-D is a single-engine, four-seat, metal short take-off and landing low-wing aircraft (Fig.5). The aircraft is equipped with dual control system. Fixed tricycle landing gear with the front wheel 9.74 m wing span is equipped with slotted ailerons, Fowler flaps and automatic slats. The aircraft height is 2.8 m and its length is 7.24 m. The aircraft is equipped with Lycoming O-540 engine with power of 235 KM.
