FINAL REPORT

ACCIDENT 2022/6240

STATE COMMISSION ON AIRCRAFT ACCIDENTS
INVESTIGATION

AIRCRAFT – GLIDER MDM-1 „Fox”, SP-3828

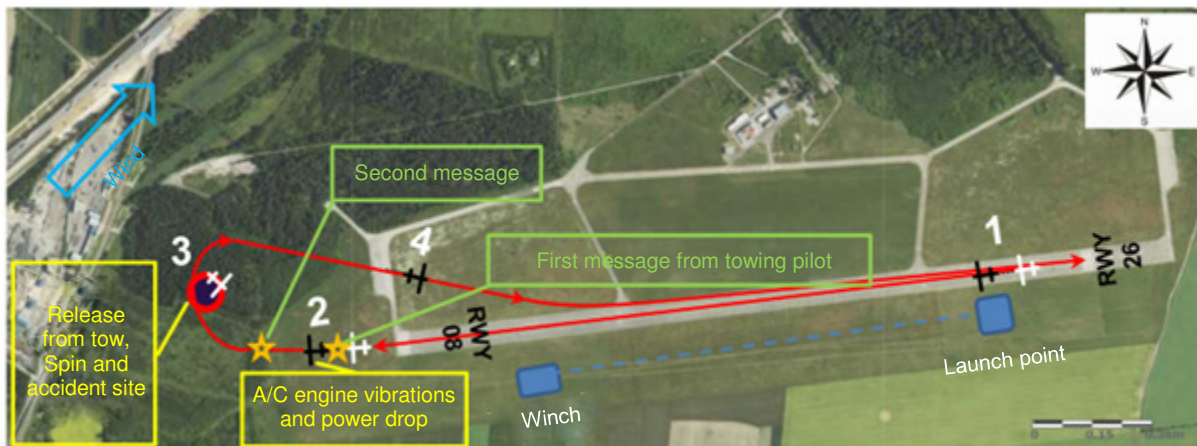
The third flight (Fig. 1), during which the glider accident took place, was performed again in a two-person crew.

Fig. 1 The path of the flight made by the team, the glider accident site, and the path of the flight and landing of the tow plane [source: Geoportal / PKBWL]

The aeroplane pilot then commenced a right turn (to the north) in order to return to the aerodrome and suggested by radio that the glider crew release the tow if possible. During the turn, the tow cable was released from the glider [3]. Although the towing pilot felt the release, he could not see the glider in his rear view mirror. The pilot completed the turn, reduced the engine speed and landed "down wind" [4]. The aeroplane completed the landing run near the threshold of RWY 26, on the eastern side of the aerodrome.

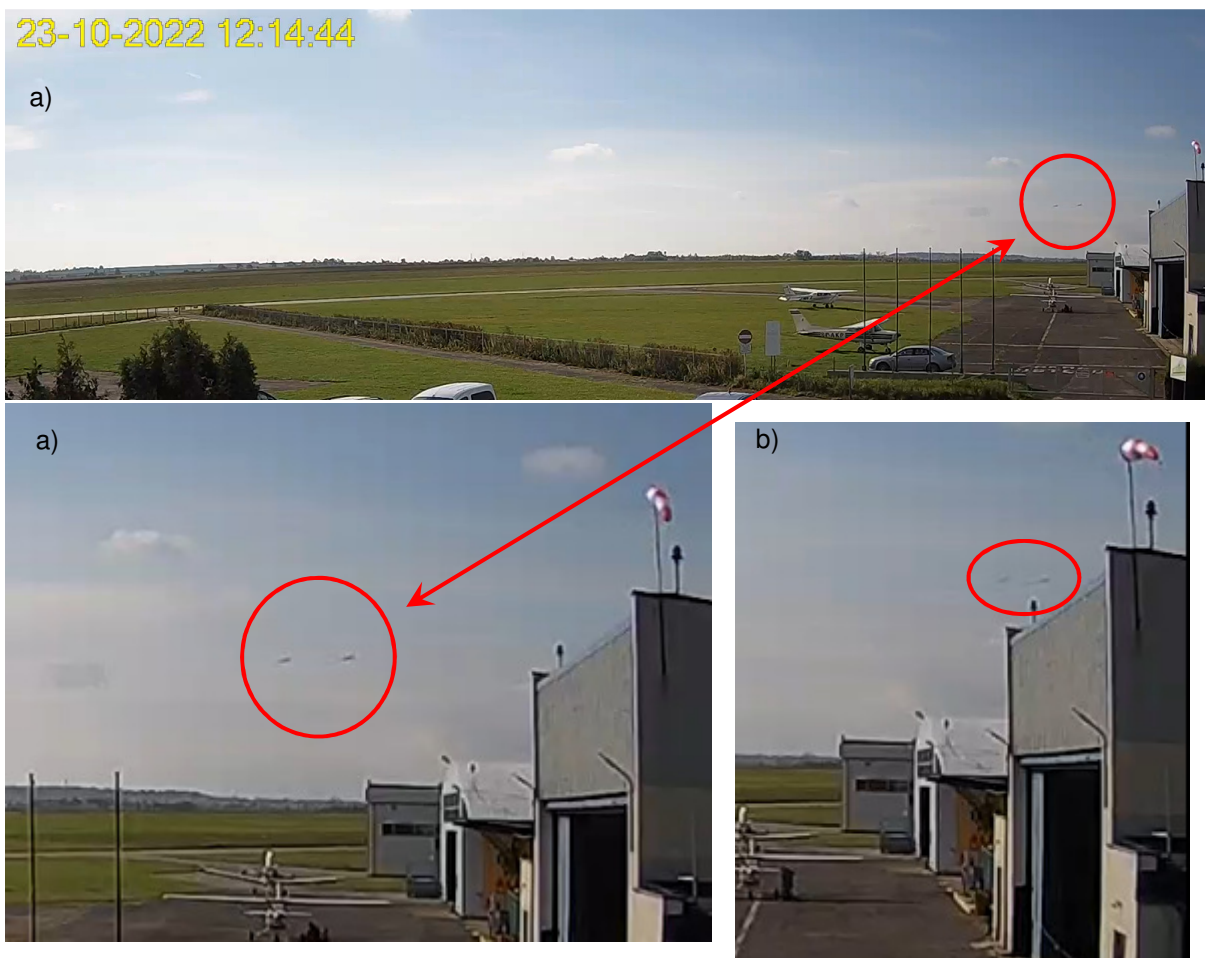
In the vicinity of the end of RWY26, the team reached the height of around 70÷90 m AGL (Fig. 19a). After passing the RWY end, flying past a group of model-makers, the aeroplane pilot felt engine vibrations. He notified the glider crew by radio: "Fox, we have an engine problem!"

Fig. 19 a) The aeroplane-glider team after take-off from RWY26. A wind cone on a hangar can be seen on the right of the photos; b) A 6 sec. interval relative to a) – it is the last recorded position of the team [source: aerodrome CCTV/PKBWL]

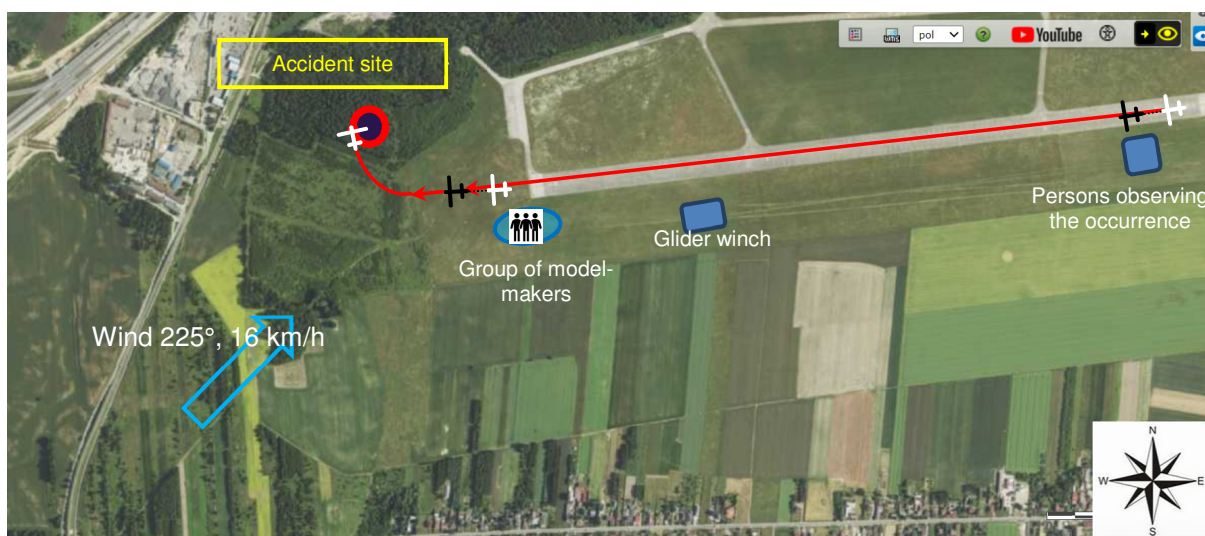
In a hypothetical left turn of the team upwind, the glider crew, after releasing the tow line, could have considered emergency landing "directly" on the wastelands or fields to SW or even S of the aerodrome (Fig. 20). Such a landing would have likely ended in damage to the glider and, probably, injuries to the crew, but it would have ensured survival. Landing in the direction "toward the forest" and downwind, with the ground speed increased by the wind speed (the tailwind component) would have had to end in the glider's collision with obstacles (trees) and would have immensely exposed the crew to at least serious injuries. Hence, this is probably why the "Fox" crew decided to continue the turn "toward the aerodrome".

Fig. 20 The position of fields to S of RWY26 of the EPRU aerodrome [source: Geoportal / PKBWL]

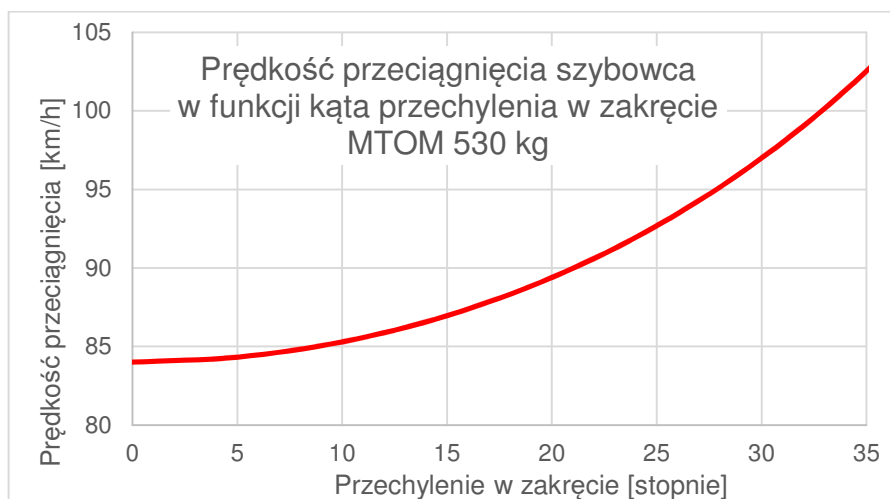
The relation between the stall speed and bank angle in a turn for the maximum allowable mass in flight is shown in Fig. 21. It must be noted that stall speeds of the "Fox" SP-3828 glider for a mass of more than 530 kg were even greater than depicted below.

Fig. 21 Estimated relationship between the stall speed of the glider and the bank angle in a turn
[source: PKBWL]
