# FINAL REPORT

**Occurrence No.: 2374/16**

**Aircraft: Hummingbird 300 LS helicopter, SP-YLN**

**6 September 2016**

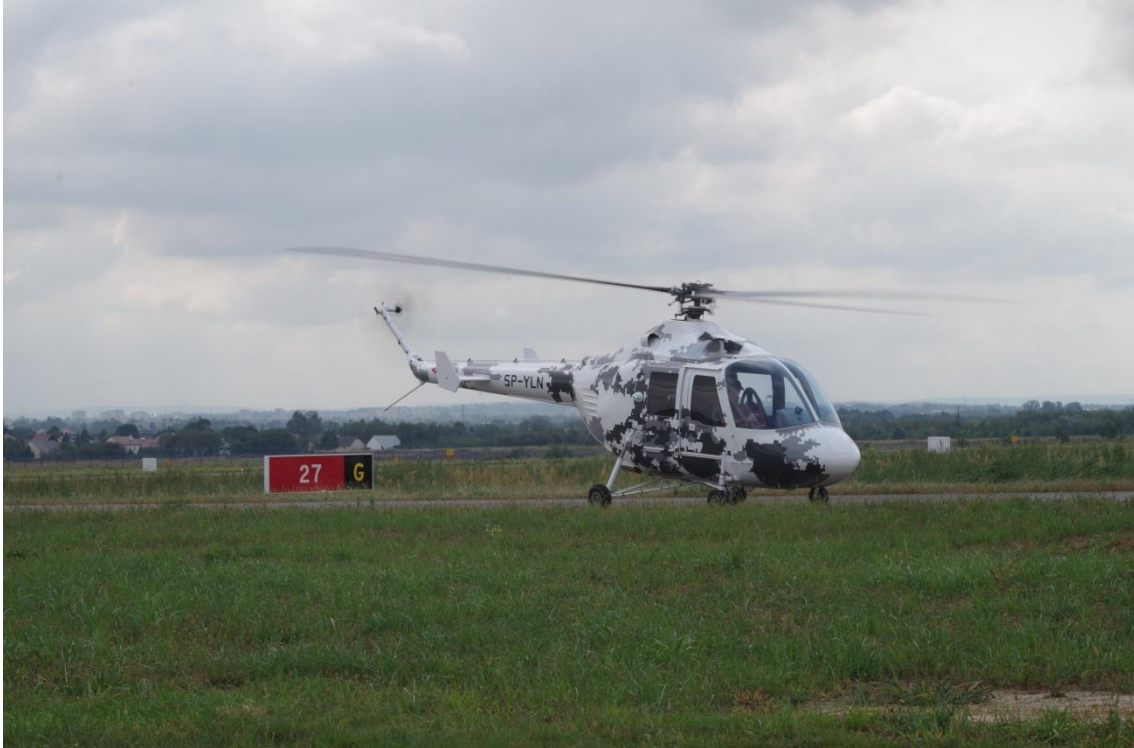
Figure 3. The helicopter during the tests on TWY G (photo: Operator)

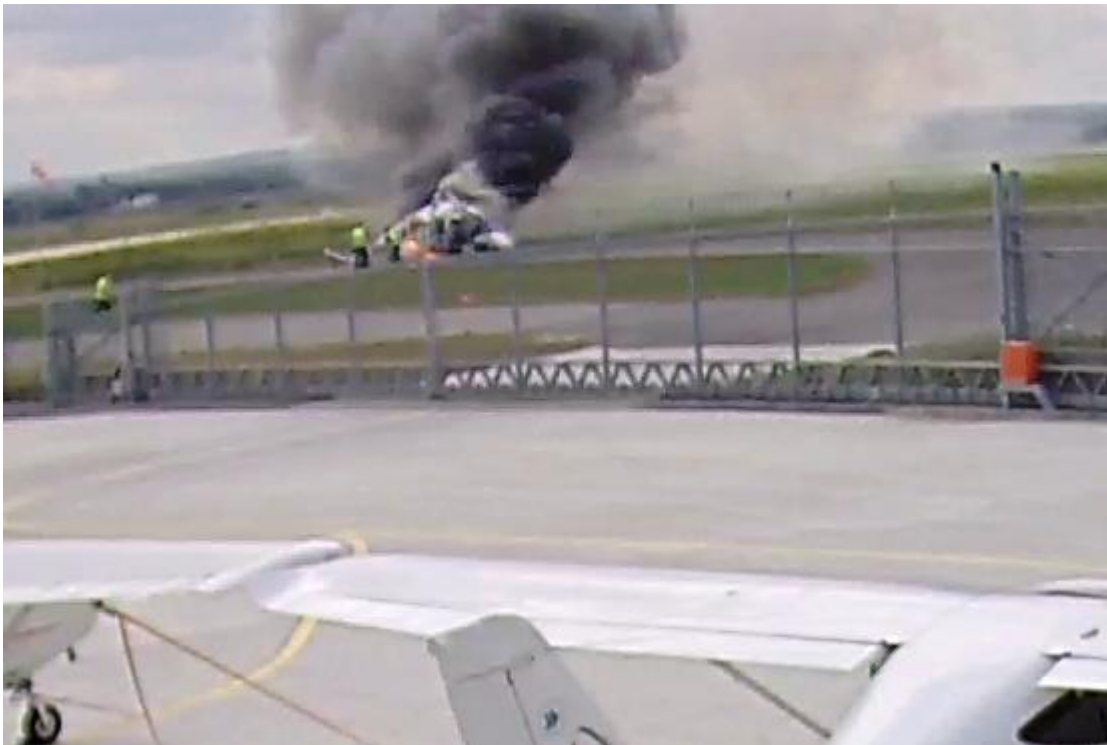
The pilot, assessing that the action with portable extinguishers would not be successful, asked EPRZ TWR to activate Airport Fire Brigade. After about 2 minutes three vehicles of the Airport Fire Brigade arrived and extinguished the fire in a short time.

Figure 6. Firefighting action by maintenance personnel, prior to arrival of Airport Fire Brigade (photo from Operator surveillance camera)

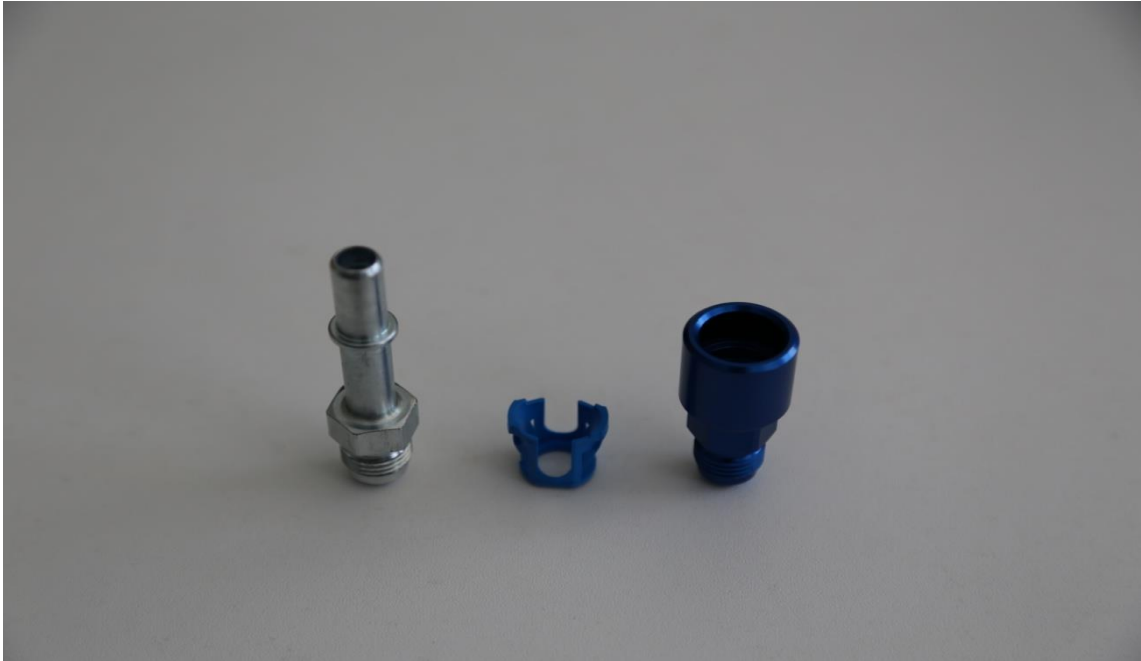
It was found that a plastic insert designed to prevent the connector from disconnection was missing. Following the finding, the Commission decided to conduct a thermal test of the quick connector on a test stand. New connectors P/N 640850 purchased from manufacturer were used for the thermal tests.

Figure 8. The tested connector. From the left: a connection pipe of 3/8 inch, plastic insert preventing disconnection of the coupling, 3/8 inch female connector (photo: SCAAI)

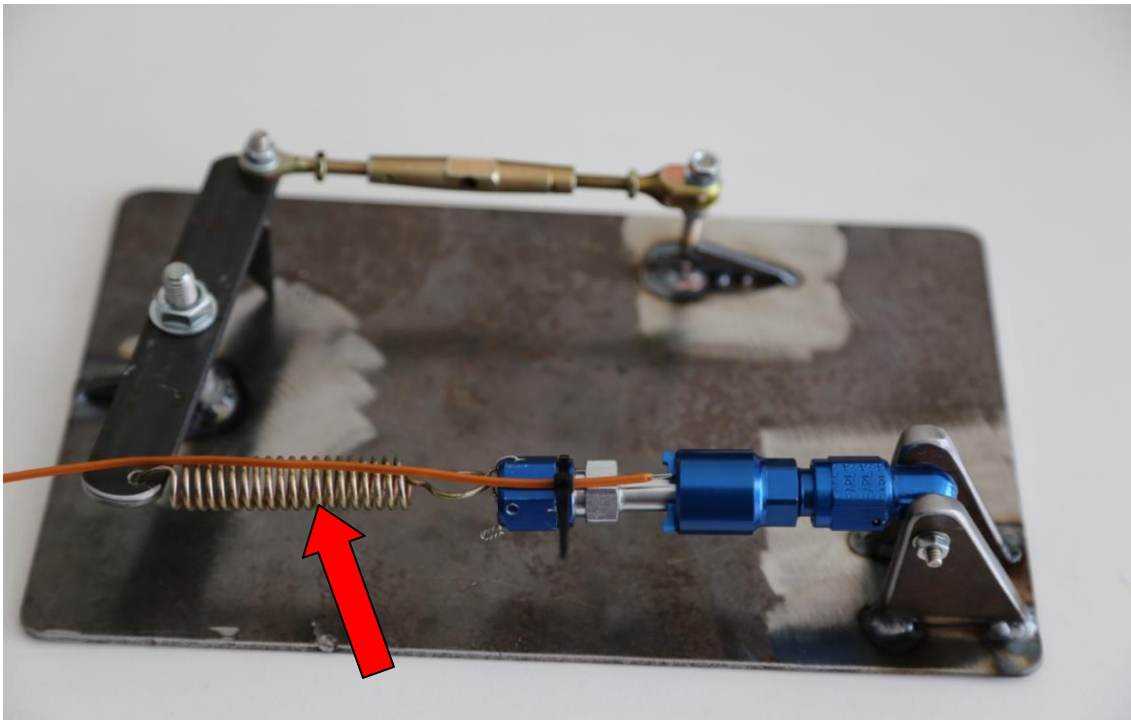
Figure 9. The connector prepared for the test with a thermocouple (photo: SCAAI)

The first connector was gradually heated, starting from 31,6°C. **At the temperature of 212°C melting and flow of the plastic insert** preventing the connector from being disconnected was observed (Figure 11).

Then the second test was carried out on a new connector. It was placed at the temperature of 117,3°C and then it was subjected to further heating. **After reaching the temperature of 275°C, the tested quick connector disconnected.**

In the next test, the third connector was placed on the test stand and it was gradually heated starting from the temperature of 21°C. The connector was preheated to 120°C and then the temperature was increased by 20°C every 10 minutes. At the temperature of 167°C the beginning of softening of the plastic insert was observed. **At the temperature of 192,6°C, the tested quick connector was completely disconnected.**

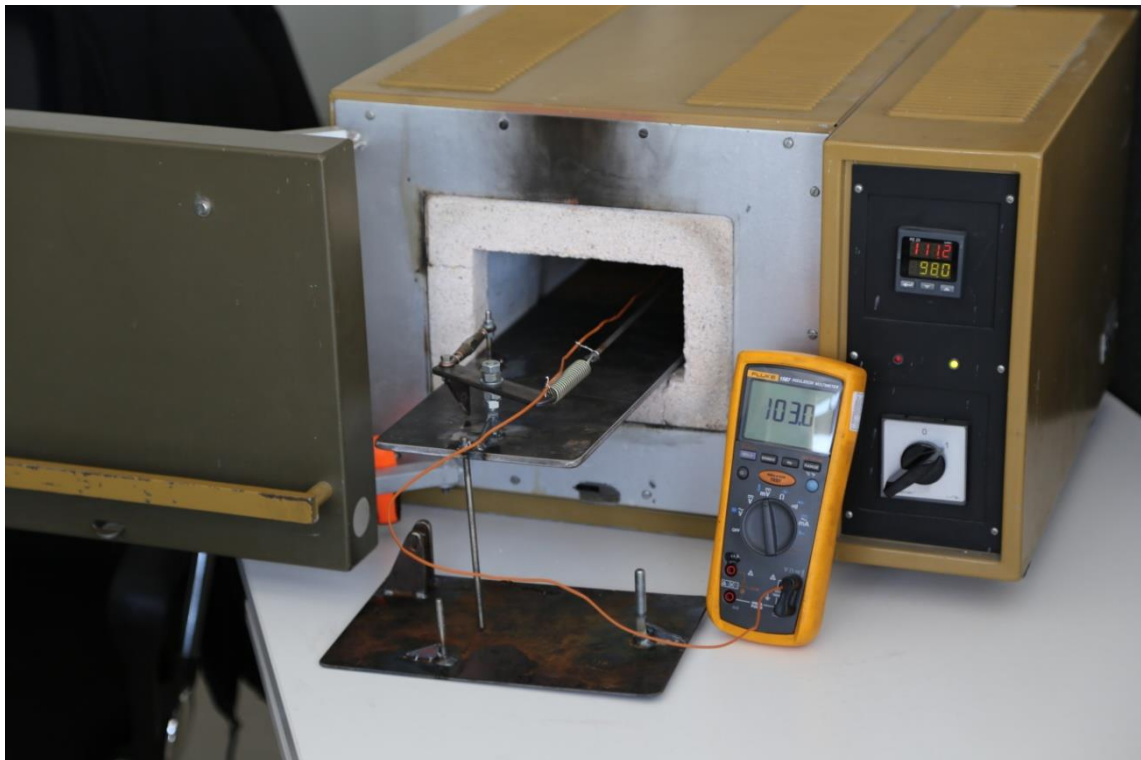
Three tests were carried out. The tested connectors were placed in a heating device to create the temperature conditions similar to those in the helicopter engine compartment at the time of the occurrence.

Figure 10. The stand for testing the impact of temperature on the connector (photo: SCAAI)

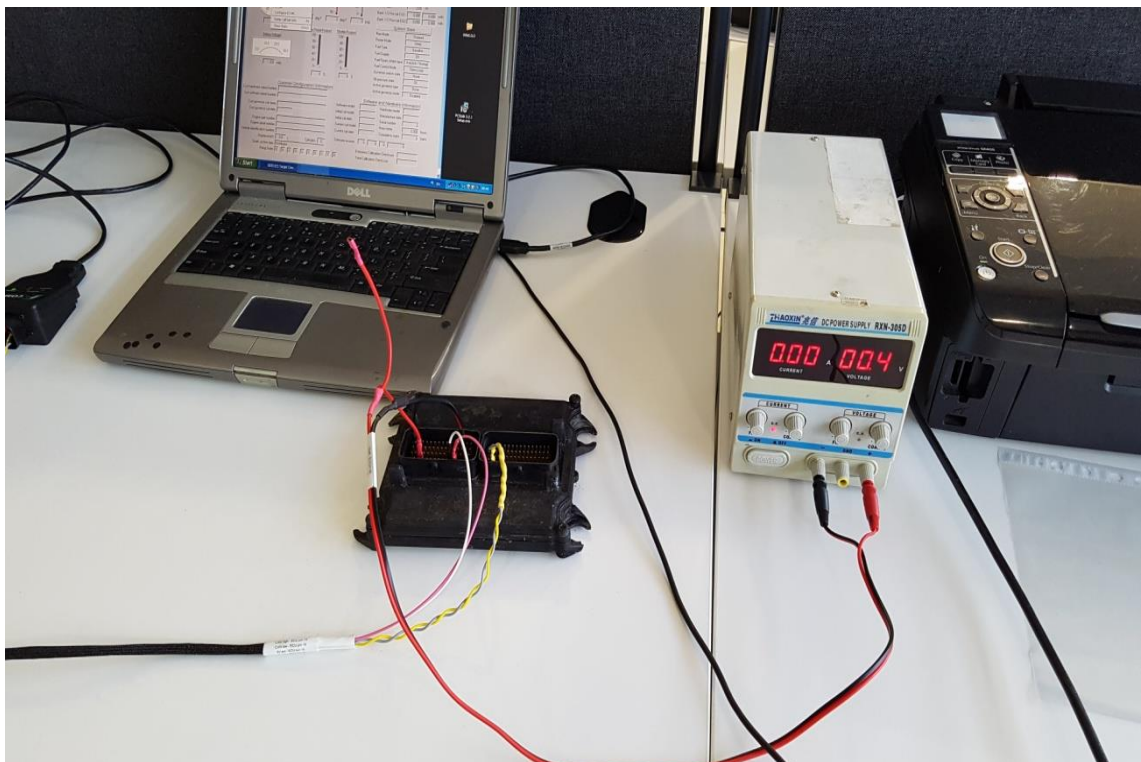
The Commission attempted to read out the ECM from the LS7 engine installed on the helicopter. Since no data from the ECM could be retrieved, its housing was removed and it was found that its electronic components were separated from the main board. Loose elements (due to melted solder connections) were protected.

Figure 16. Measuring stand prepared to read out data from the ECM of LS7 engine (photo: SCAAI)

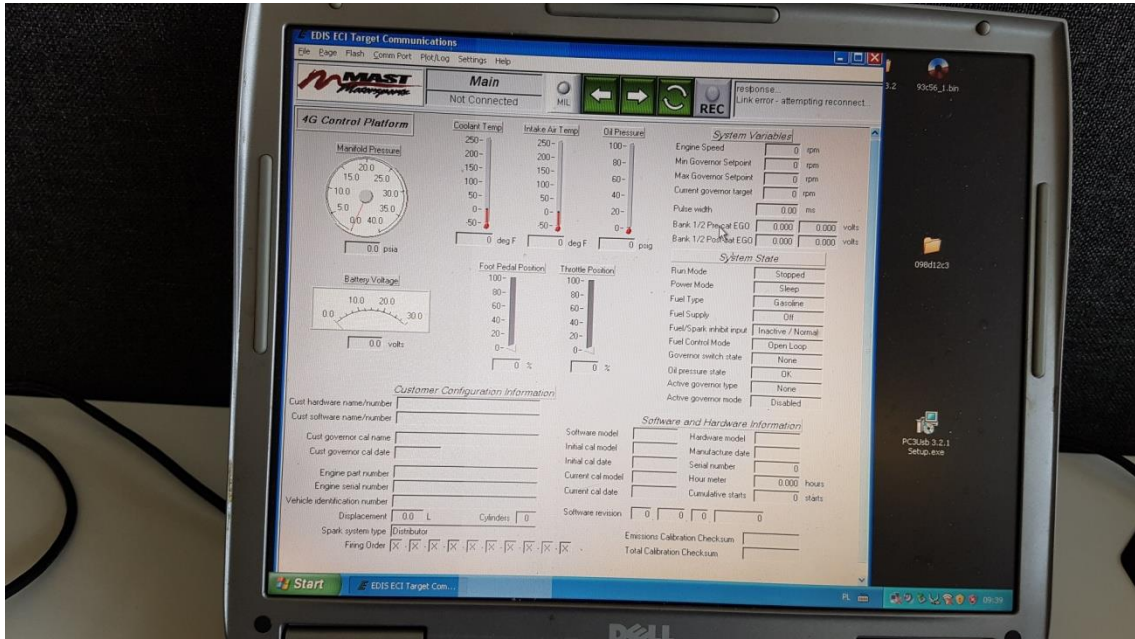
Figure 19. Screen of the measuring apparatus (photo: SCAAI)
