**REPUBLIC OF SERBIA
CENTER FOR INVESTIGATION
OF ACCIDENTS IN TRANSPORT**

FINAL REPORT ON ACCIDENT INVESTIGATION

Aircraft: Embraer E190-200LR
Registration: OY-GDC
Year of manufacture: 2008
Serial No.: MSN 190000204
Owner: Marathon Airlines S.A., Republic of Greece
User: Air Serbia
Accident location: “Nikola Tesla” Airport, Belgrade
Accident date: February 18th, 2024
Accident time: 17.39 (LT)
Flight phase: Take-off

August, 2025

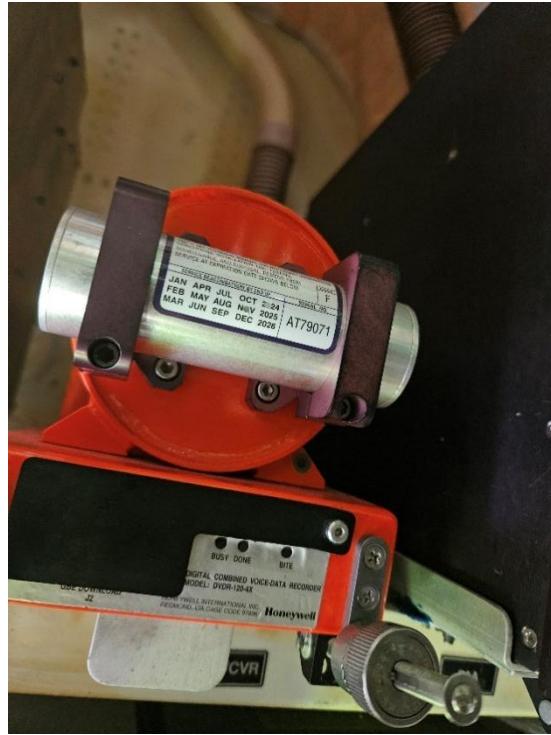
Figure 22. DVDR – Digital Voice Data Recorder

During the investigation process, the Flight Data Recorder (FDR) and Cockpit Voice Recorder (CVR) (Figure 22) were removed from the aircraft and sent for download and analysis in coordination with the aircraft manufacturer. The data retrieved from the FDR will be analyzed in Section 2 of this report.

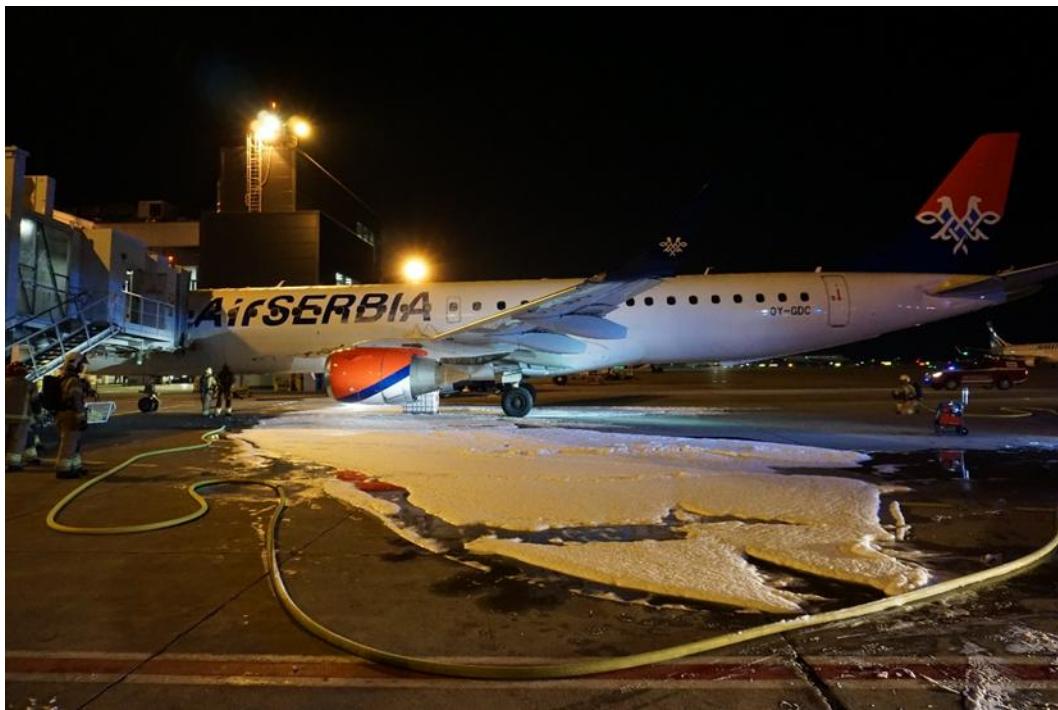
Figure 23. Implementation of aircraft fire protection measures

No fire occurred as a result of this accident. Immediately after landing, the airport fire service implemented precautionary fire protection measures. While the aircraft was positioned at parking position "C2", a fire vehicle was deployed to apply foam over the fuel leaking from the left wing.

Additionally, a cooling fan was positioned at the left rear side of the aircraft as a precaution in case of landing gear overheating.

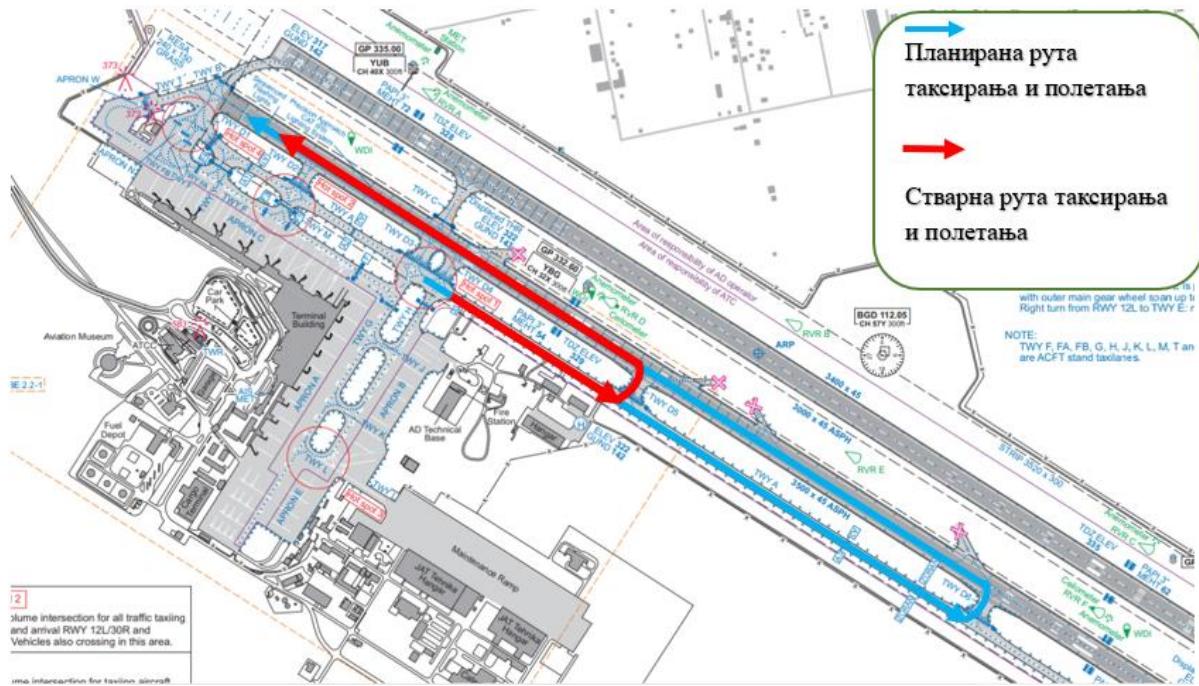
Figure 25. Planned and actual aircraft taxi route during take-off preparation

The aircraft took-off from intersection D5 with Flaps 1 and thrust set to TO-3 with 33 deg of Flex Temperature. The take-off performance assessment determined that the minimum required take-off distance for the given ATOW (45.737 kg) is 1,440 meters with Flaps 4, TO-1 and No Flex Temp (see item 2.2 for more details).

- An error was noted in entering runway 30L via intersection D5 instead of D6.
- A data entry error was identified in the performance application: the wrong runway was selected, and there is a possibility that the **Take Off Shift** length was mistaken for **TORA**, based on the incorrect runway.

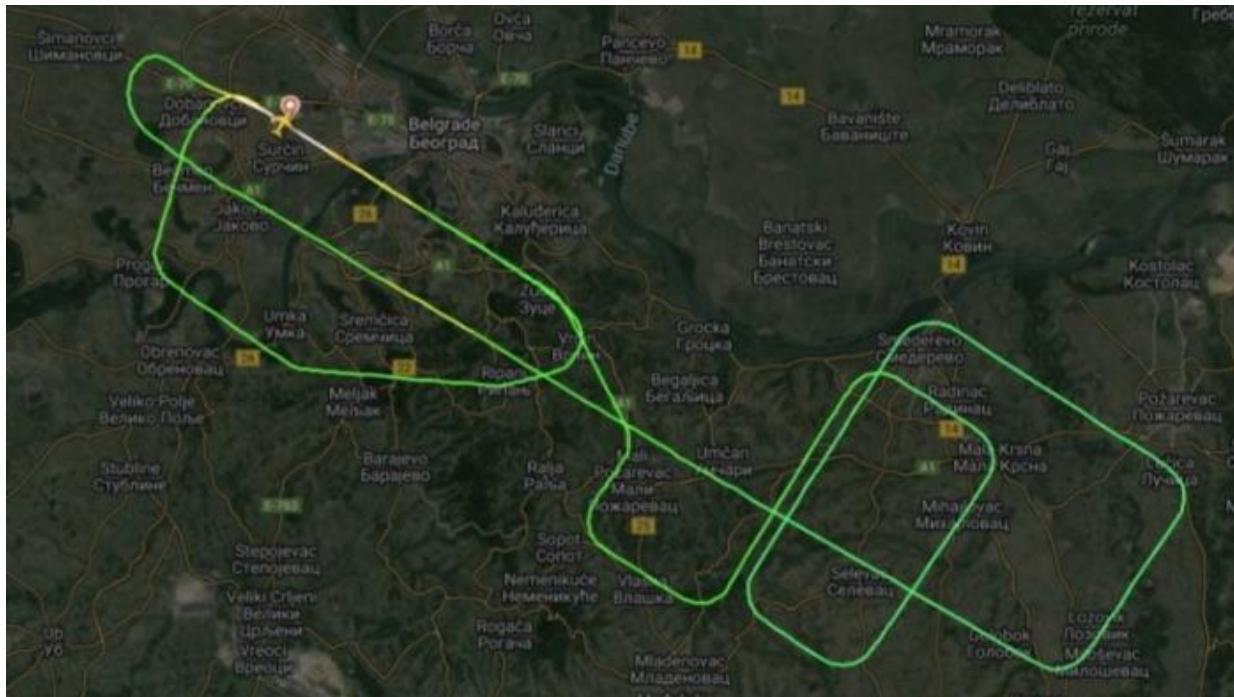
Figure 27. Aircraft flight path: takeoff, low pass, holding pattern, landing.

The aircraft then performed a low pass over the runway heading 300 with the landing gear extended. ATC verified that no issue was detected with the landing gear. During the descent and low pass, the crew reported a problem with the flaps, along with increased vibrations. After the low pass, the crew elected to proceed with landing. They executed a left turn into the airport traffic pattern and successfully landed on runway 30L at 18:36 LT.
