# FINAL REPORT

SERIOUS INCIDENT 2022/4594

State Commission on Aircraft Accidents Investigation (PKBWL)

AIRCRAFT – Boeing B-737/800-83N, SP-ENU

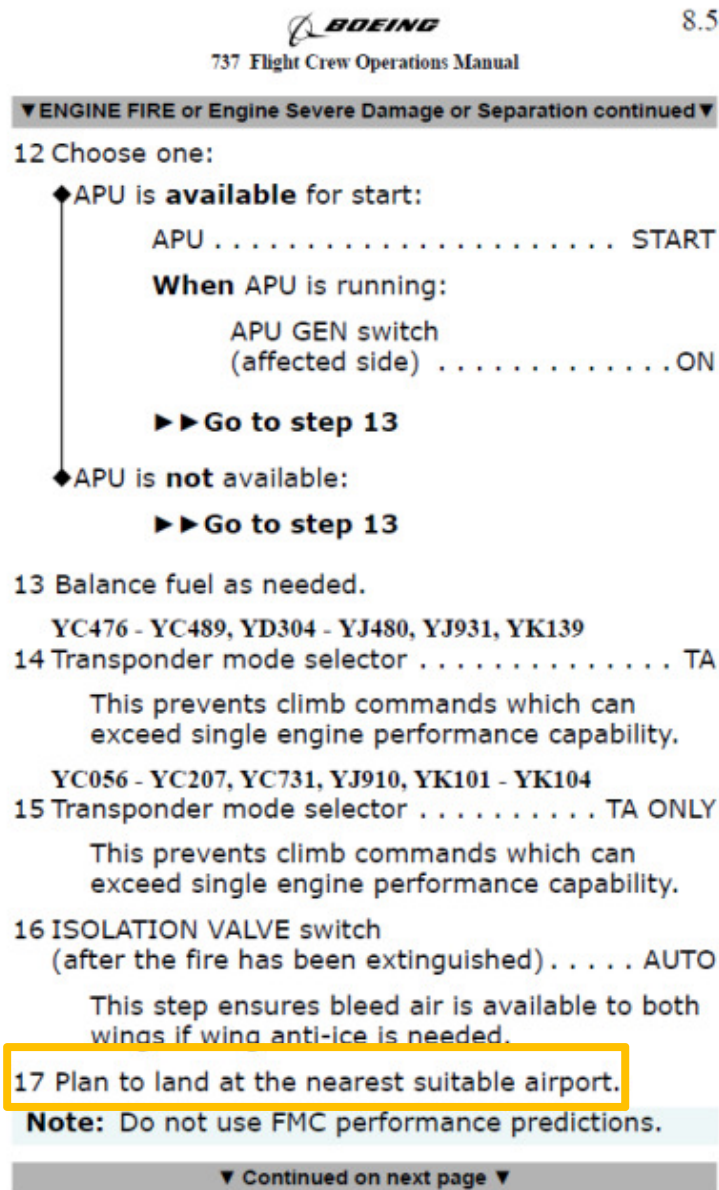
Plane moved from the stand with 10 min. delay at 14:45. Plane departed from EPGD airport at 14:59 (RWY11, SID: DEXIR 2H). Take-off roll, lift-off and climb with no deviations. After departure crew received clearance to climb to FL280. Plane departed southbound and during the climb pilots requested to deviate from standard routing to heading 220° to avoid clouds. Further right turn to heading 230° for next 20 NM was requested. At around FL110 crew noted abnormal noise coming from the engine number 2 and unstable engine parameters. Plane slightly banked to the right. Commander decided to take control and became role of PF. FO took the role of PM. Captain disconnected A/P and A/T. Gently reduced thrust of Eng. No. 2 to idle. Crew called to ATC with request to stop to climb and maintain FL120 in holding pattern. Crew reviewed situation and stated that plane is controllable and failed engine can be re-started in the air. Based on crew`s statement N1 and N2 indications (Flight Data Monitoring analysis is included in this section) have been observed, however due to unusual sound crew decided to complete check-list: *NNC. 8.2. Engine Fire or Engine Severe Damage or Separation*. No fire was detected. Completing mentioned check-list, Engine Fire Switch was not pulled up. Below extract from Boeing QRH with related memory items when completing Engine Severe Damage or Separation check-list. Point 4 shows that Engine Fire Switch must be pulled. Which crew did not complete.

At the end of the check list (point 17 – see fig.16) it is clearly stated that landing should be completed at a nearest suitable airport, and the check list directs the crew to the *QRH NNC 7.32 One Engine Inoperative Landing ()* check list.

Fig. 16. Extract from Boeing QRH. Part of the check-list: Engine Fire or Engine Severe Damage or Separation.

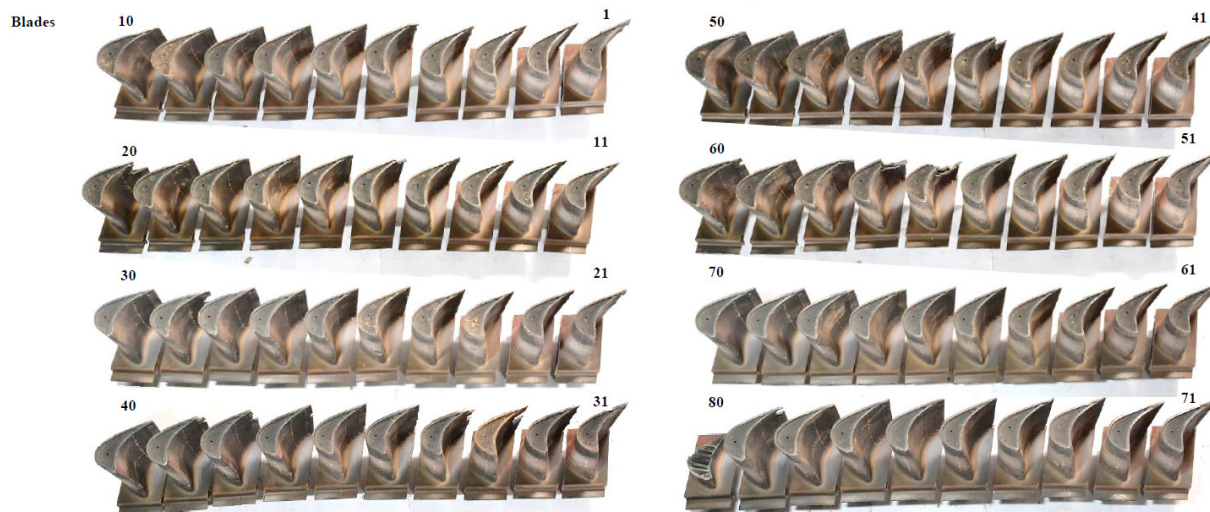
Fig. 20. Top-down photos of complete blade set returned for evaluation in the as received condition.  
Source: Report: CFM56-7B Engine Serial Number: 874306 HPT blade airfoil separation event Metlab evaluation summary. P.7.

Prime Blade #80 airfoil liberation:

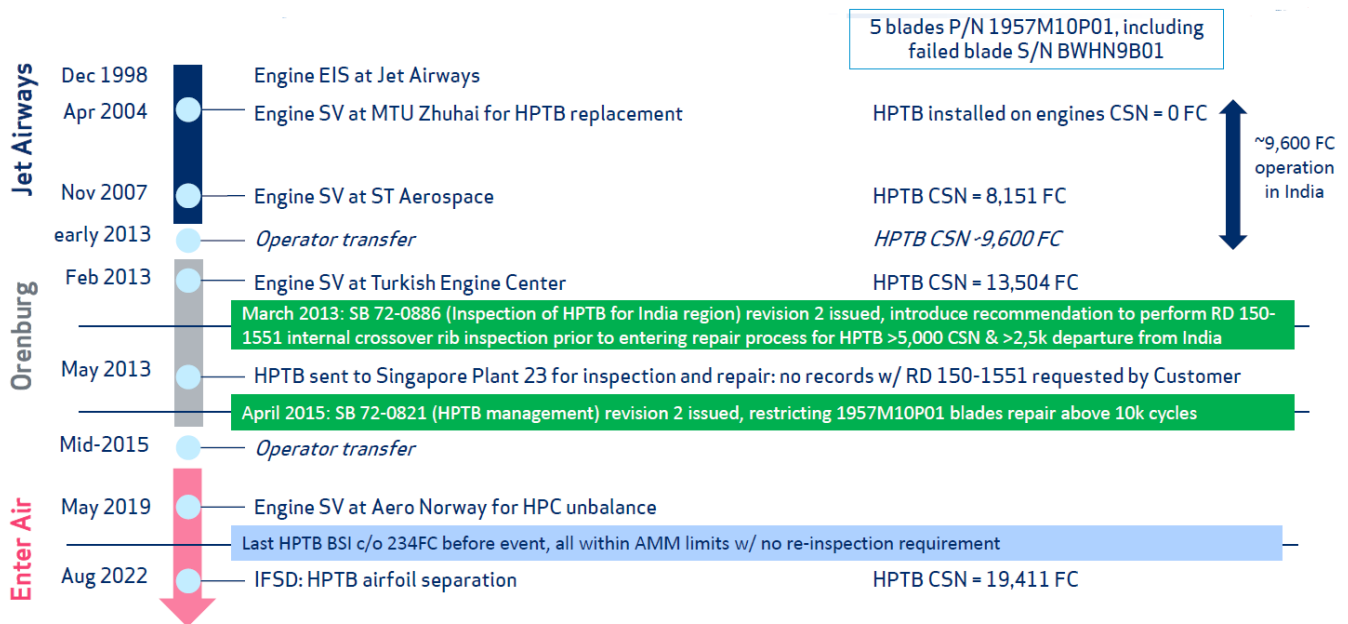
- HPT blades sent from Turkish Engine Center to the Singapore Plant 23 for inspection and repair.
- Safety Bulletin (SB) 72-0886, Repair Document (RD) 150-1551 HPT blade internal rib evaluation was a required inspection based on the operational history of this engine which met the “operational departures within India” SB criteria (HPTB > 5,000 CSN & 2,5 k departure from India).
- Singapore Plant 23 does not have records stating RD 150-1551 was requested by the customer during the 2013 engine overhaul:
  - Aug 2022: IFSD HPTB CSN = 19,411 FC.
- RRT is 25,000 FC, per SB 72 0821.
- Last HPTB BSI c/o 234 cycles before event, all within Aircraft Maintenance Manual (AMM) limits with no re-inspection requirement.

Fig. 27. History of engine SN 874306.

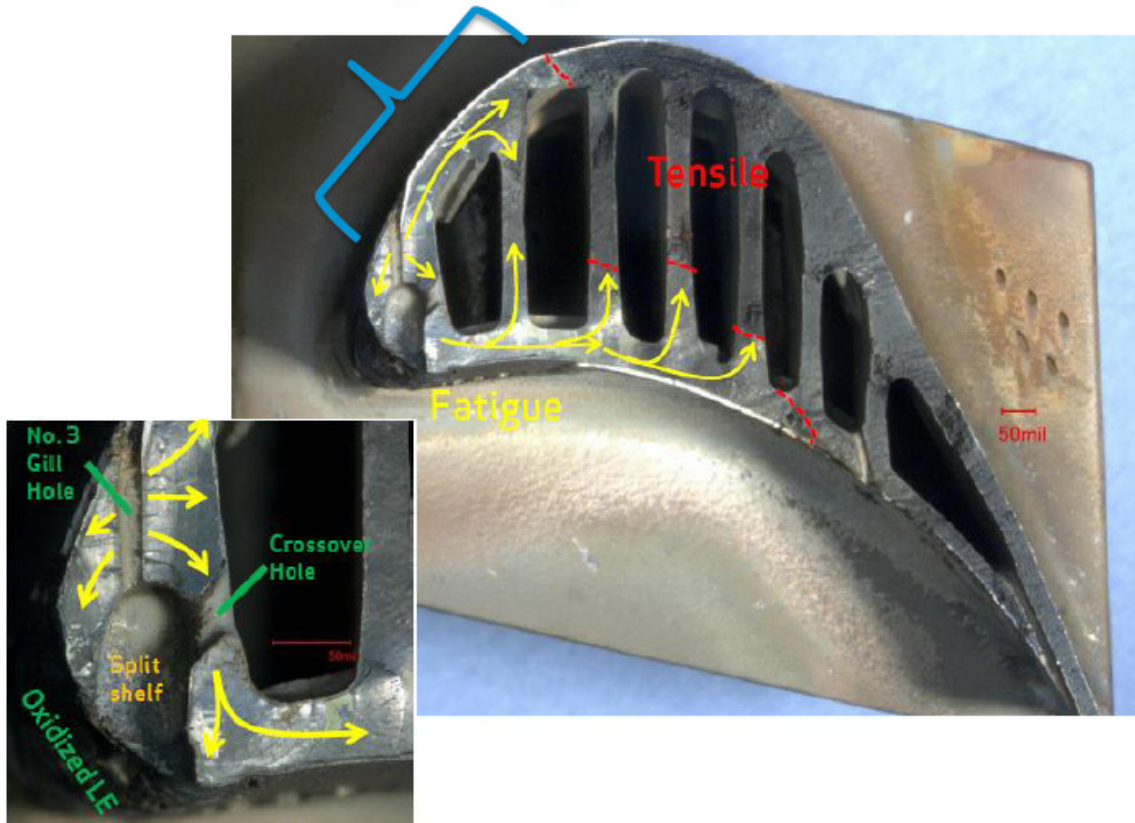
Not ESN 874306, example only

Crack lengths typically reach  
0.40" – 0.50" prior to separation

Fig. 29. LE cracking field experience - example.

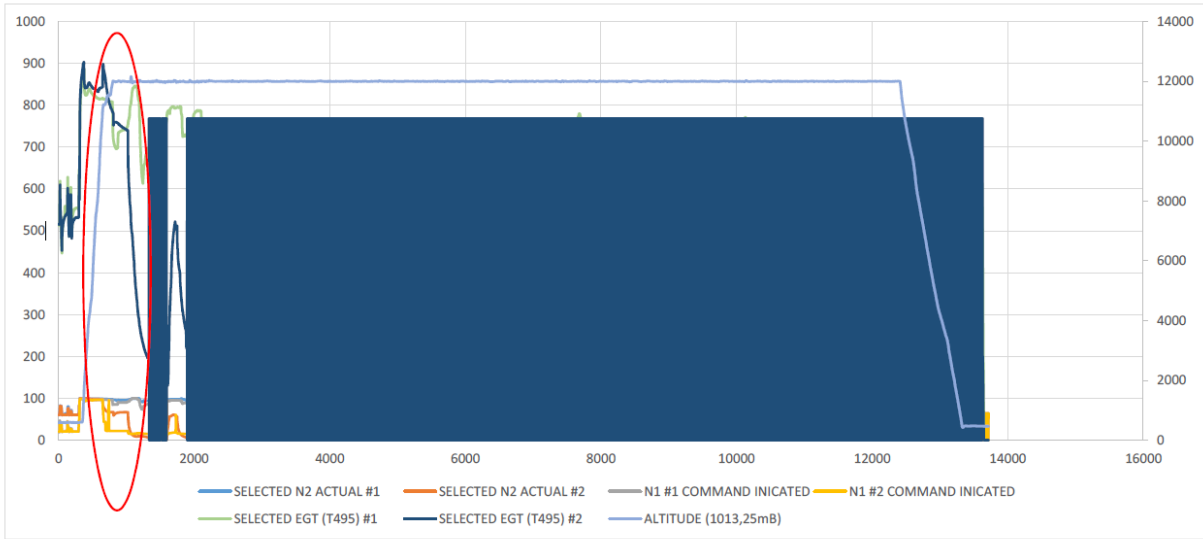
Fig. 31. Both engines graph. Highlighted initial part of the flight with detailed indications of selected parameters described in the agenda of the graph.

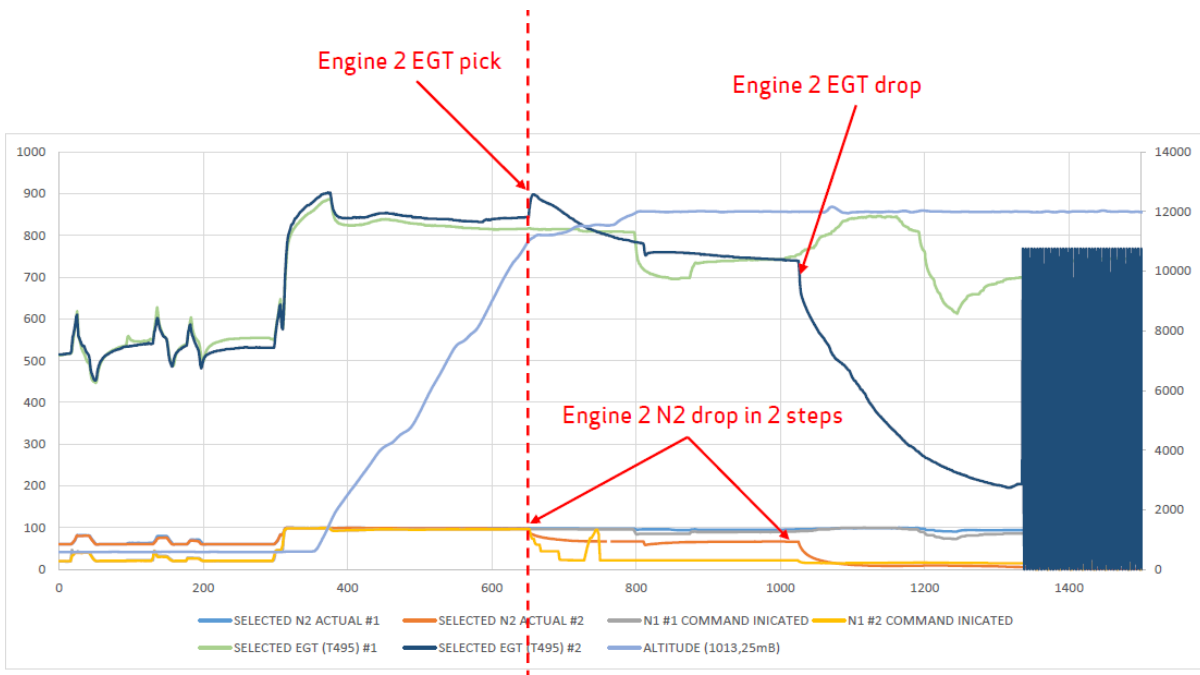
Fig. 32. Both engines graph. Highlighted time of incident (red dashed line) with detailed indications of selected parameters described in the agenda of the graph.

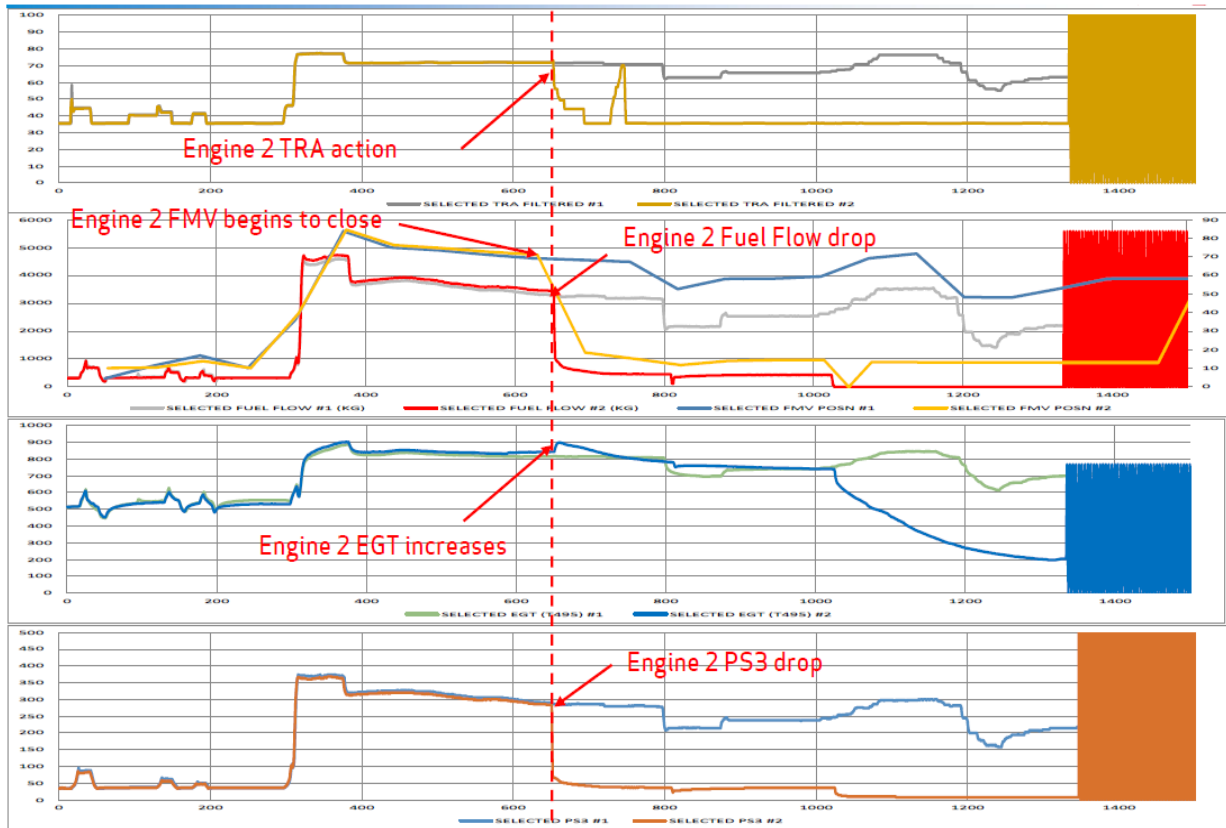
Fig. 33. Both engines graph. Highlighted time of incident (red dashed line) with detailed indications of selected parameters described in the agenda of the graph.

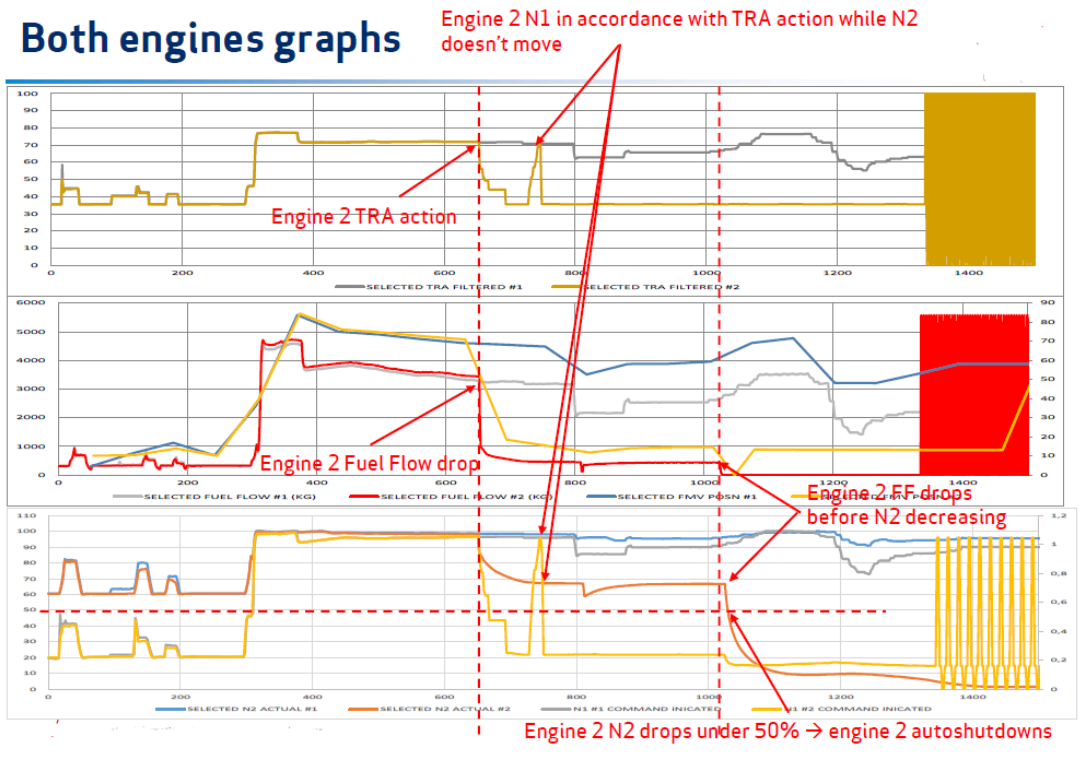
Fig. 34. Both engines graph. Highlighted time of incident (red dashed line) with detailed indications of selected parameters described in the agenda of the graph.

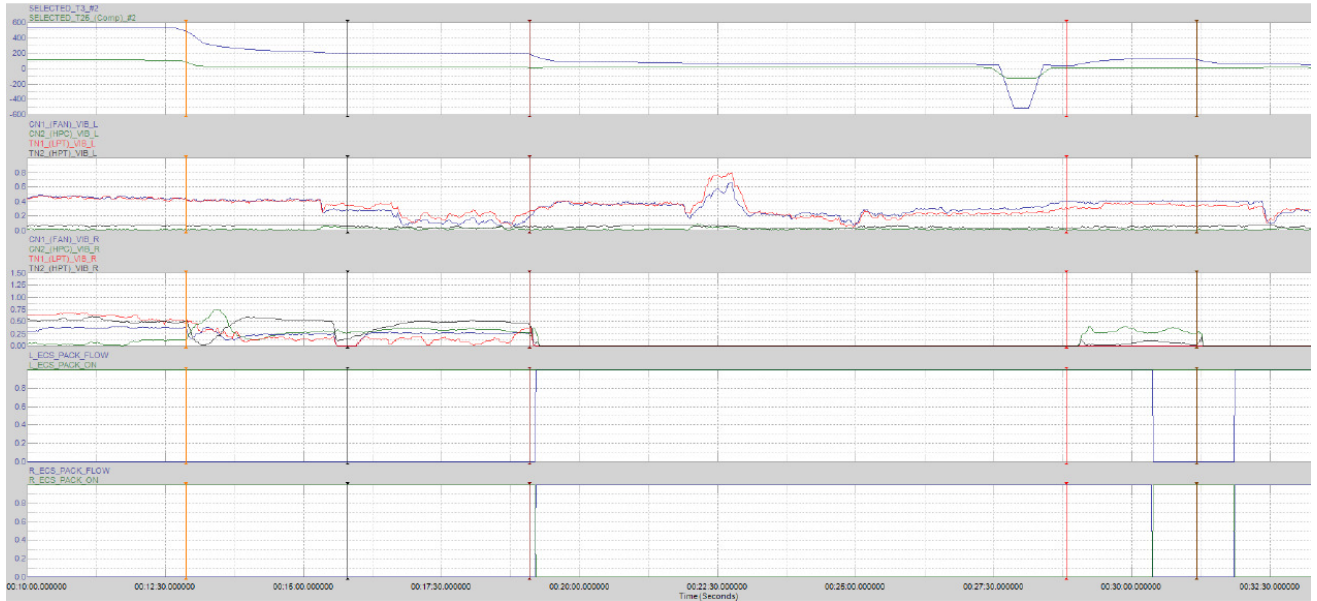
Fig. 41. Vibrations.

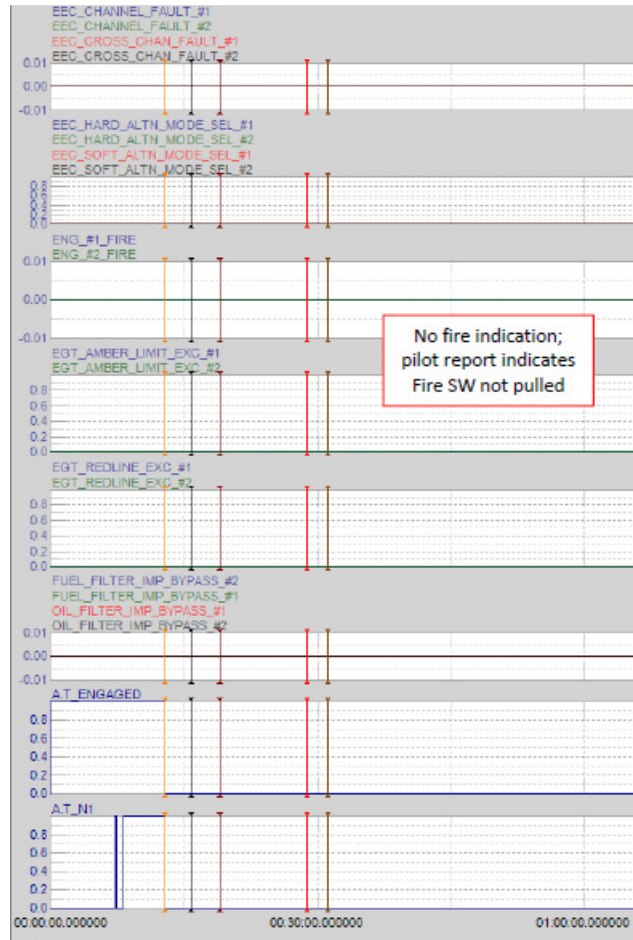
Fig. 42. EEC operated in normal mode with no EEC faults A/T disengaged during the flight.
