State Commission on Aircraft Accidents Investigation

FINAL REPORT

2023-0039

Robinson Helicopter Company R44 II, OK-LUK

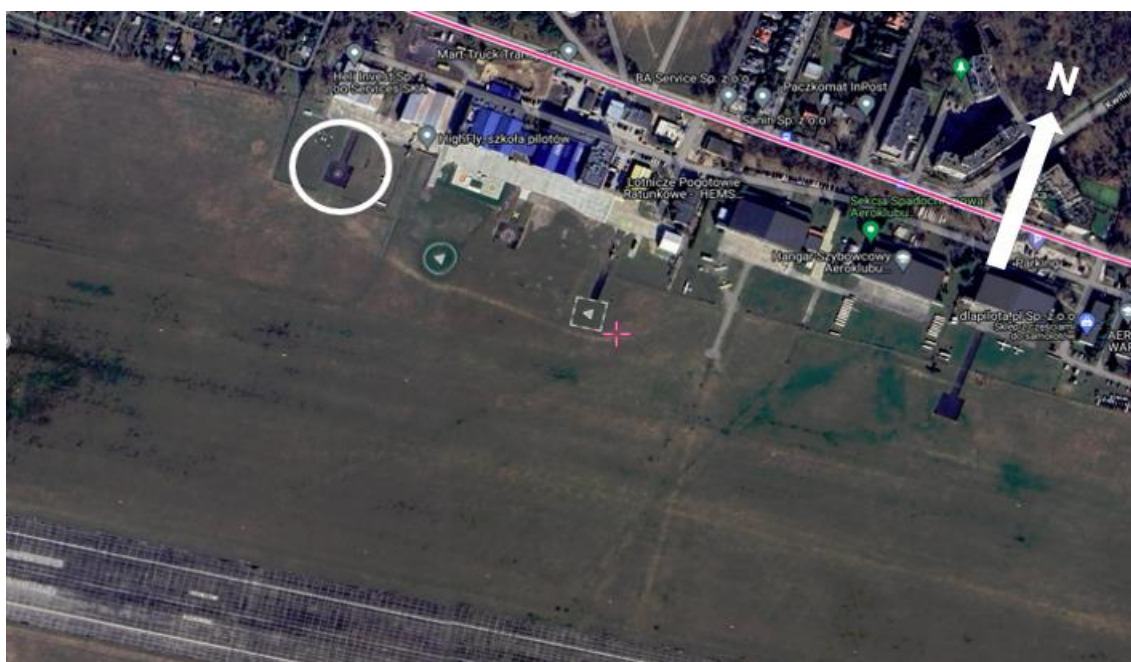
Figure1. Place of the occurrence: Warsaw-Babice aerodrome (EPBC), 52°16'22" N 20°54'22" E (marked with a white circle), elevation 348 ft. [source Google Maps].

The occurrence took place on the helipad near hangar 11A at the EPBC aerodrome – Figure 1.

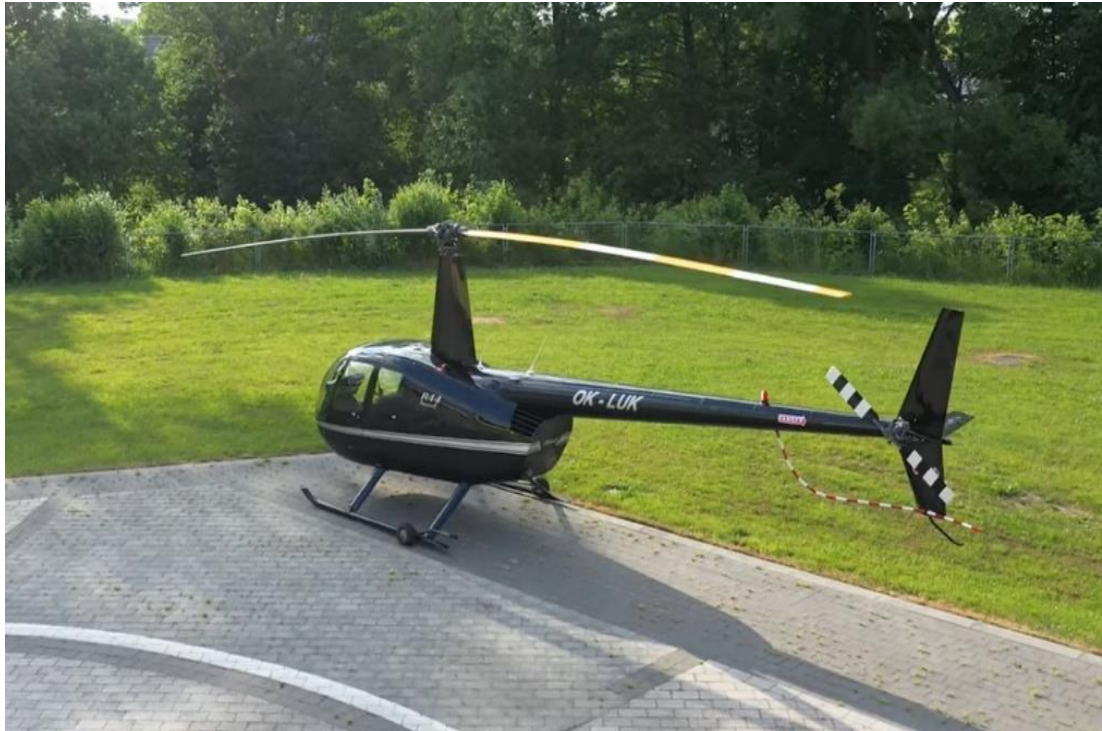
Figure 2. The helicopter involved in the occurrence [source: Facebook].

The helicopter was seriously damaged.

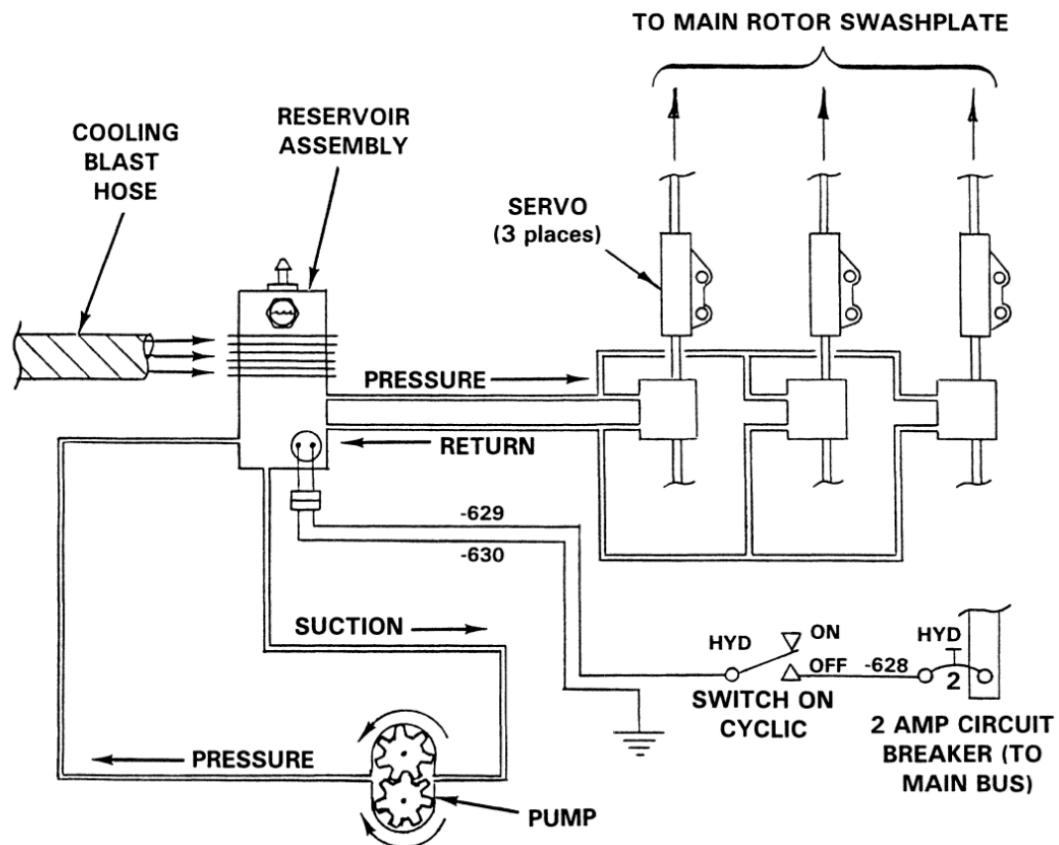
The hydraulic system consists of a gear pump driven mechanically from the main gearbox, three hydraulic amplifiers, a hydraulic tank and Teflon connection hoses with metal braiding.

Figure 3. Schematic diagram of the hydraulic system of the Robinson R44 II helicopter [source: RTR 460 vol. I].

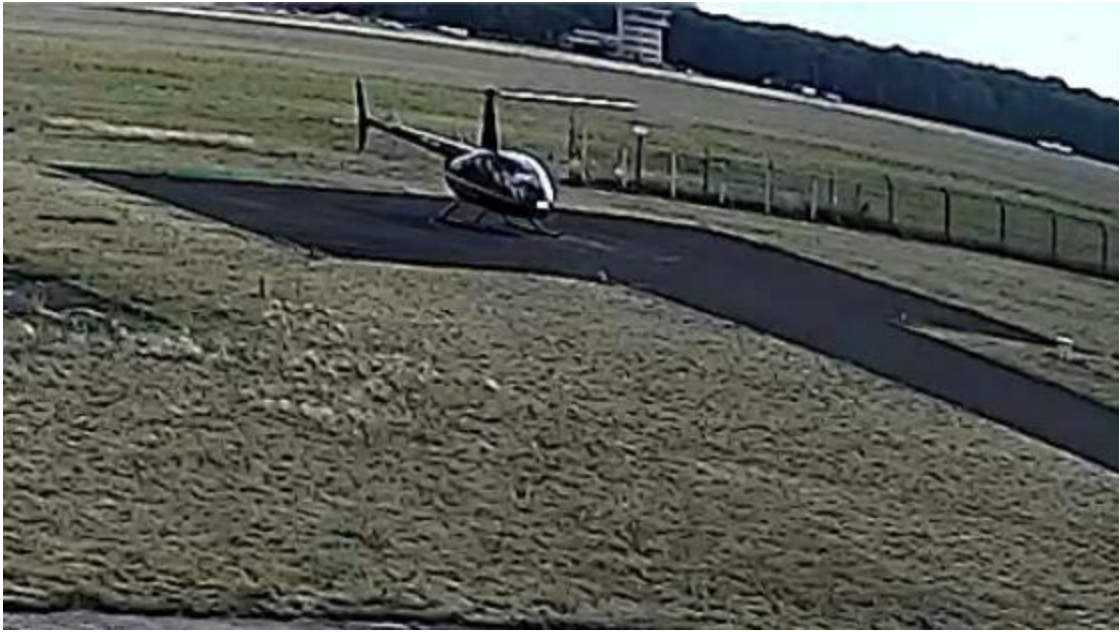
A time-lapse record of the event is shown in Figures 5–11.

Figure 5. Helicopter during start up – starting position
[source: CCTV footage].
