FINAL REPORT

of the State Commission on Aircraft Accidents
Investigation

2025-0108

UL aircraft, CH-601 "Zodiak," OK-LUA60

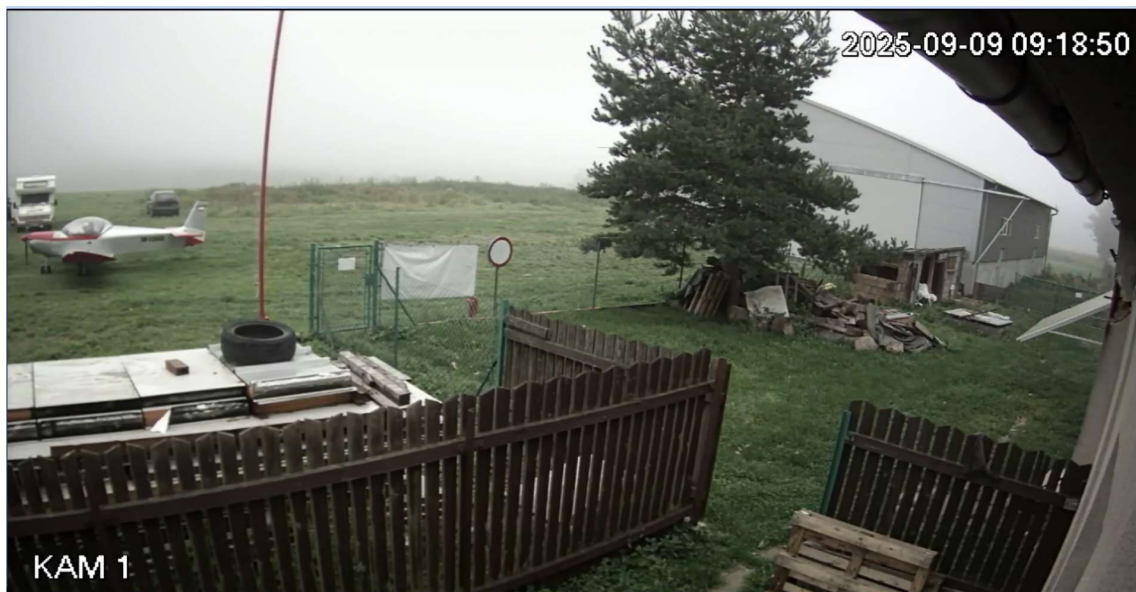
- 9:08 AM: doors opened, aircraft pulled out of hangar;
- 9:15 AM: the owner of the aircraft (who then took his seat on the left side in the cockpit) walks around the aircraft;
- 9:17 AM: pilot and pilot-passenger take their seats in the cabin;
- 9:18:40÷50 AM: engine start, test commences (Fig. 2);

Fig. 2 View from Camera 1 – aircraft is pulled out, engine is started – test commences (N view) [source: airfield monitoring/PKBWL]

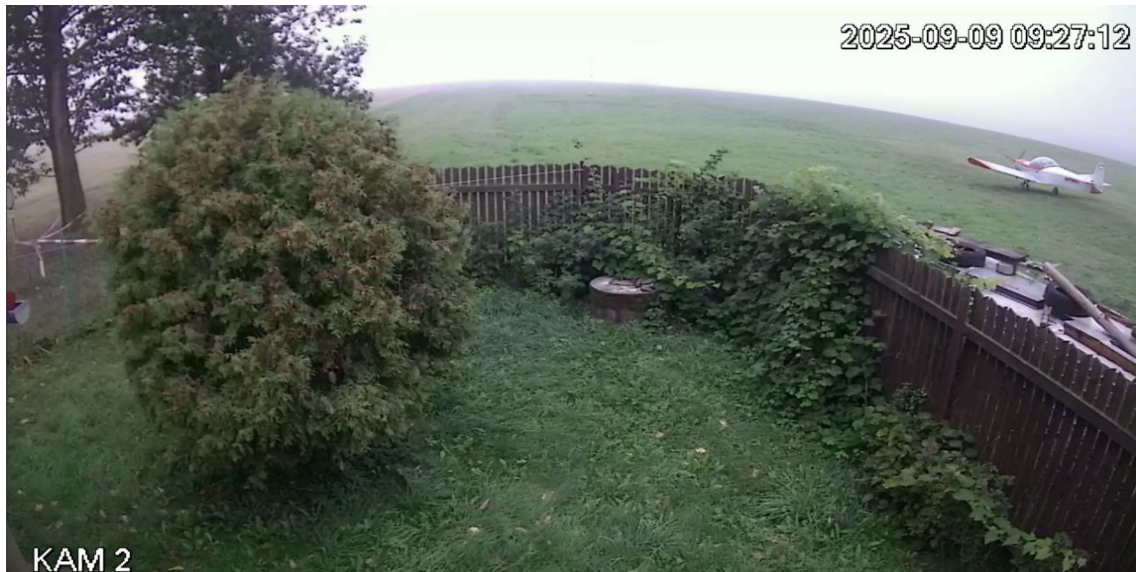
At 9:27:12 AM, Camera 2 on the west-facing wall of the building recorded the aircraft taxiing westbound (Fig. 3):

Fig. 3 View from Camera 2 – aircraft taxiing for take-off [source: airfield monitoring/PKBWL]

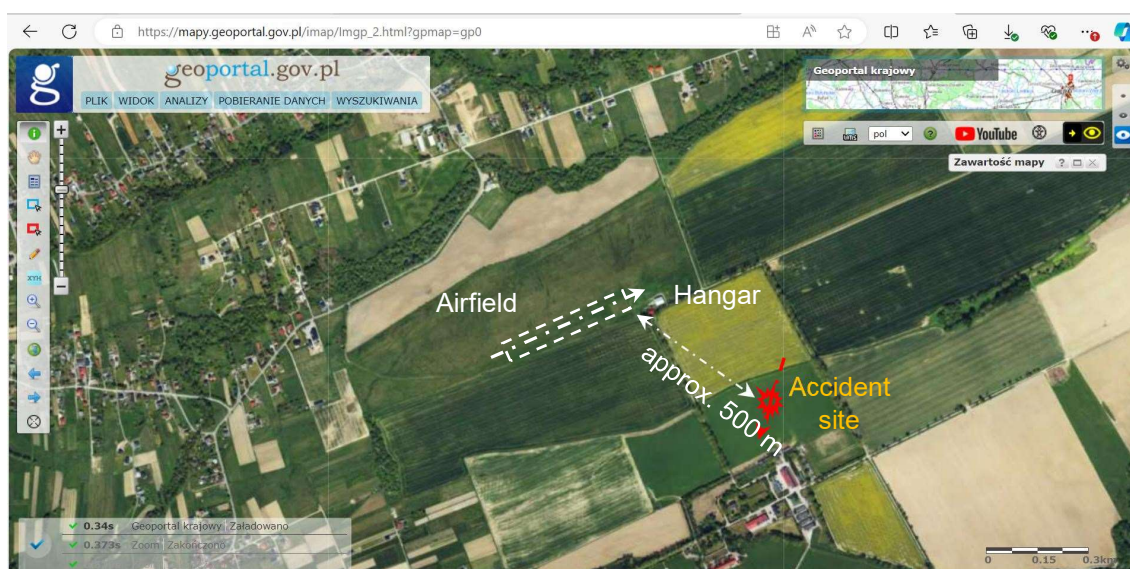
The Lipowa airfield is located on a plateau above the village of Lipowa (Fig. 10). The take-off and landing directions are located on the west-east axis (exactly $243^{\circ}/63^{\circ}$) and the length of the approximately 50-metre-wide runway exceeds 500 m. The airfield area is not fenced.

Fig. 10 The airfield in Lipowa (the white dotted line schematically shows the take-off runway - note the off-scale drawing!) together with the adjacent area and the accident site. The red arrow indicates the direction of impact [source: Geoportal/PKBWL]

On the day of the accident, a strip of approximately 350 x 40m was mowed on the airfield. Due to the extremely high relative humidity (dense fog), the grass was wet. The accident occurred at a (straight-line) distance of 500 m from the eastern edge of the airfield, south-east to it.
