FINAL REPORT

2025-0108

UL aircraft, CH-601 "Zodiak," OK-LUA60

9 September 2025, Lipowa

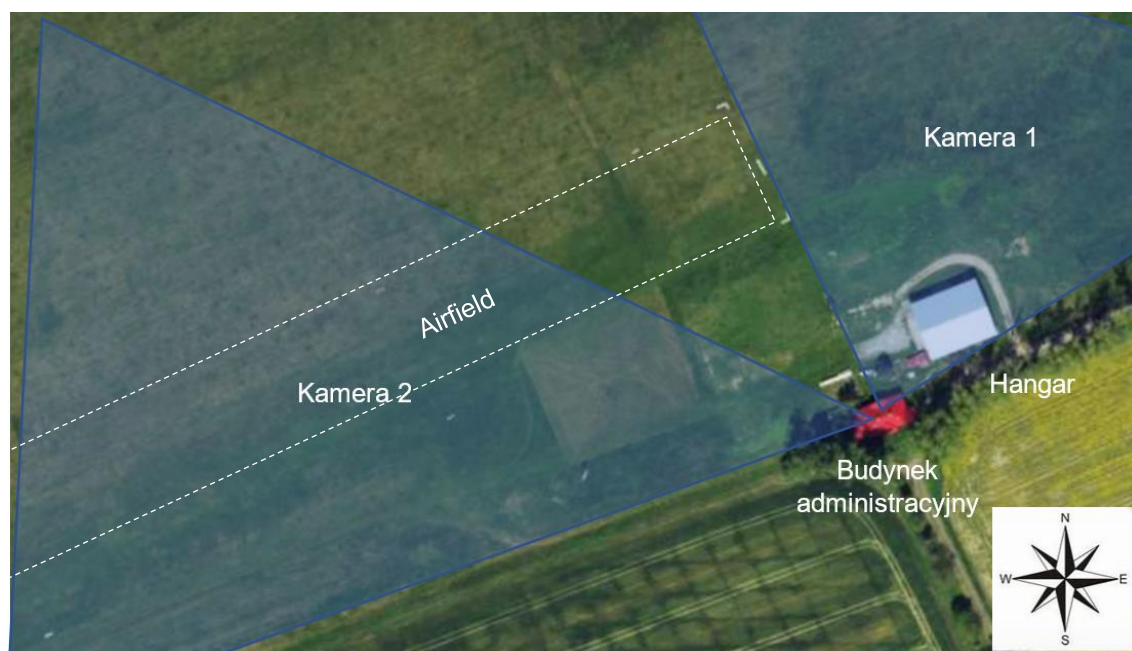
The layout and fields of view (FOVs) of the cameras are shown in Figure 1.

Fig. 1 Approximate FOVs of Cameras 1 and 2 [source: Geoportal/PKBWL]

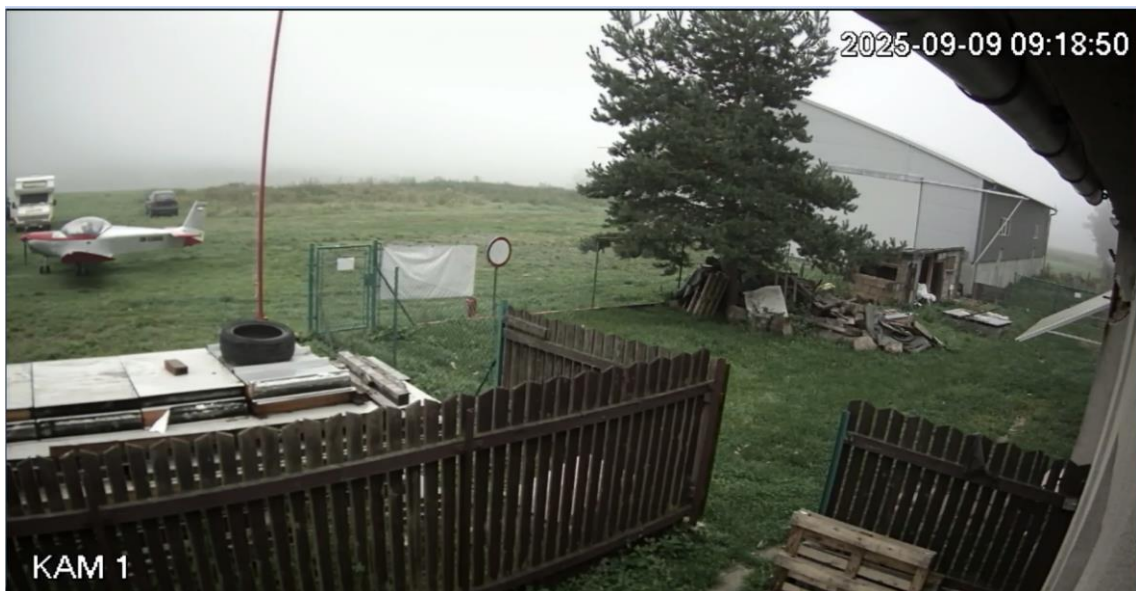
- 9:08 AM: doors opened, aircraft pulled out of hangar;
- 9:15 AM: the owner of the aircraft (who then took his seat on the left side in the cockpit) walks around the aircraft;
- 9:17 AM: pilot and pilot-passenger take their seats in the cabin;
- 9:18:40+50 AM: engine start, test commences (Fig. 2);

Fig. 2 View from Camera 1 – aircraft is pulled out, engine is started – test commences (N view) [source: airfield monitoring/PKBWL]

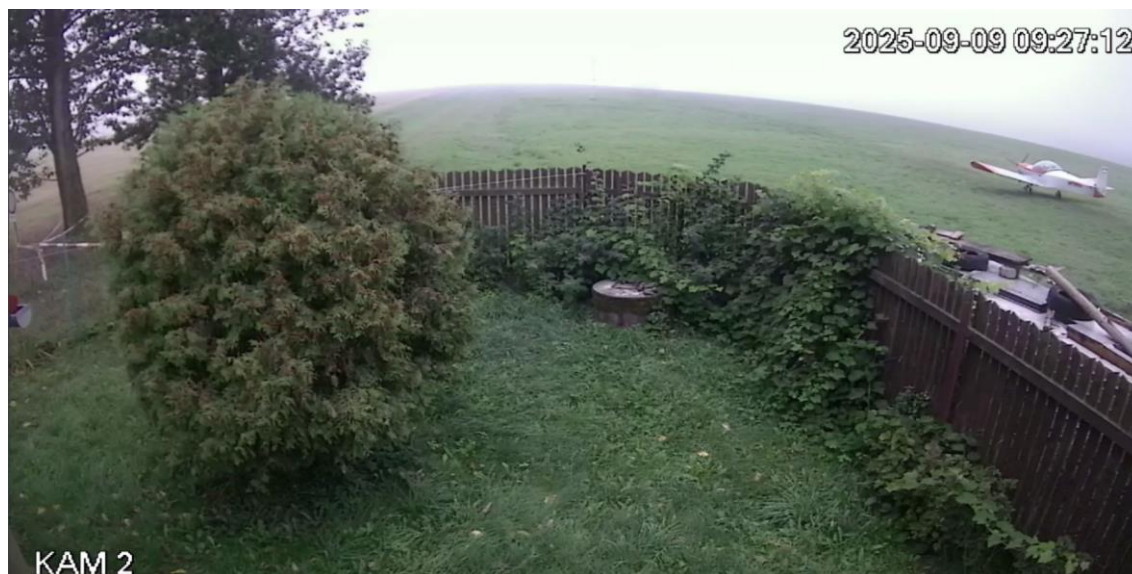
At 9:27:12 AM, Camera 2 on the west-facing wall of the building recorded the aircraft taxiing westbound (Fig. 3):

Fig. 3 View from Camera 2 – aircraft taxiing for take-off [source: airfield monitoring/PKBWL]

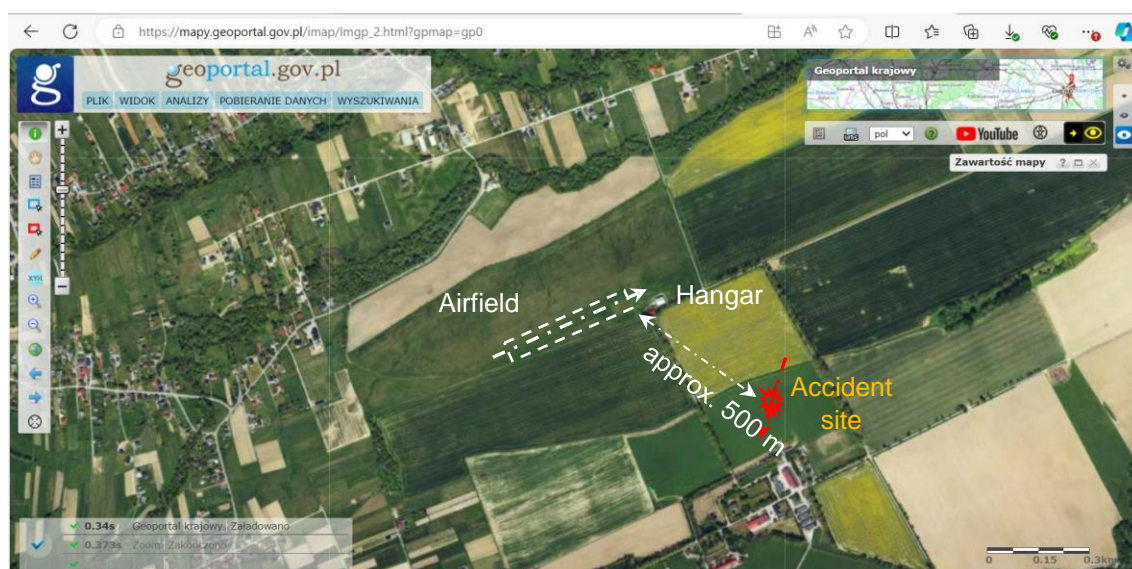
The Lipowa airfield is located on a plateau above the village of Lipowa (Fig. 10). The take-off and landing directions are located on the west-east axis (exactly 243°/63°) and the length of the approximately 50-metre-wide runway exceeds 500 m. The airfield area is not fenced.

Fig. 10 The airfield in Lipowa (the white dotted line schematically shows the take-off runway - note the off-scale drawing!) together with the adjacent area and the accident site. The red arrow indicates the direction of impact [source: Geoportal/PKBWL]

On the day of the accident, a strip of approximately 350 x 40m was mowed on the airfield. Due to the extremely high relative humidity (dense fog), the grass was wet. The accident occurred at a (straight-line) distance of 500 m from the eastern edge of the airfield, south-east to it.

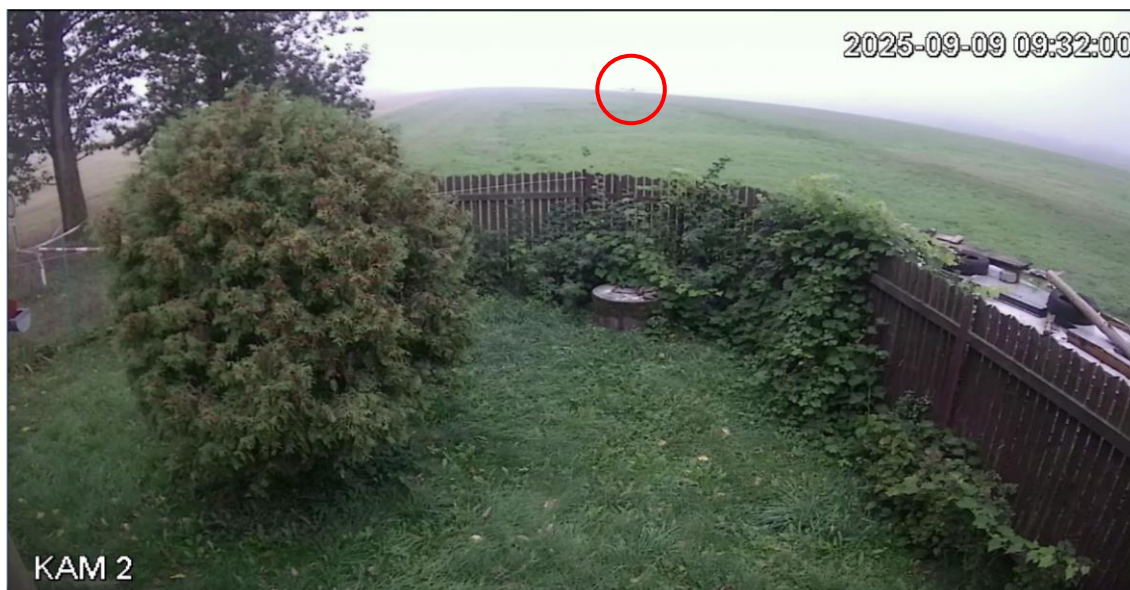
The take-off started from the western edge of the grass runway, heading 063°. At 9:32:00 AM, Camera 2 (facing west) recorded the aircraft lifting off, accelerating and starting to climb (Fig. 11).

Fig. 11 Aircraft lifting off the airfield – distance from camera is approximately 250m [source: airfield monitoring/PKBWL]

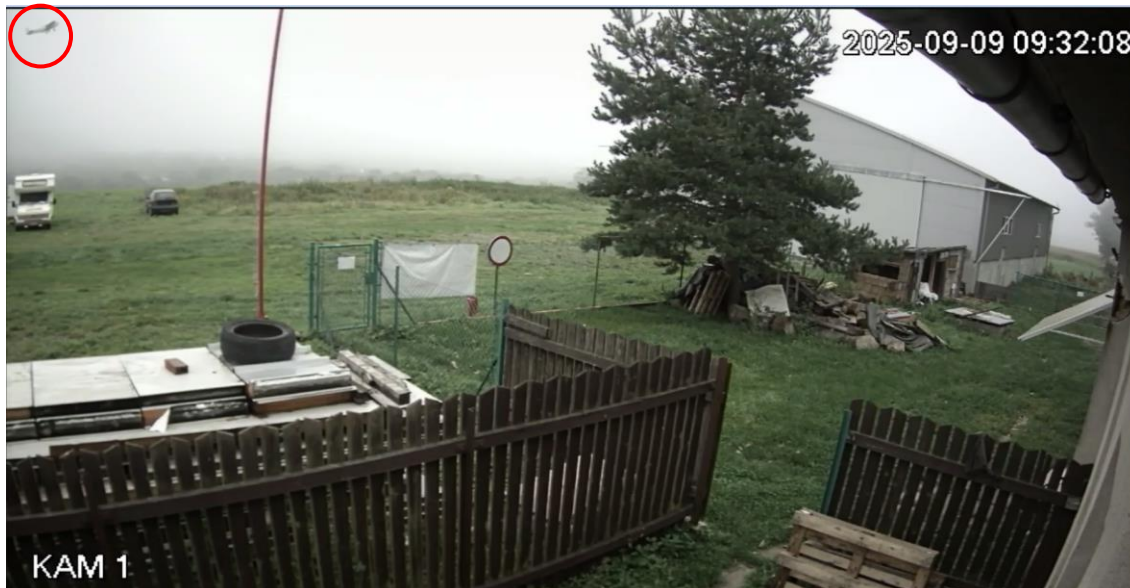
At 9:32:08 AM, Camera 1 (facing north) captured the aircraft flying over the eastern airfield boundary (Fig. 12). It was at an altitude of about 15÷20 m above the airfield, on a clear climb, tilted a few degrees to the left wing, with a course deviating to the left of the take-off axis (to the NE).

Fig. 12 Last frame of the recording showing the OK-LUA60 aircraft taking off [source: airfield monitoring/PKBWL]
